# Barrier beach breaching from the lagoon side, with reference to Northern California

## ABSTRACT

Coastal breaching, Carmel River Mouth, inlets, Lake Earl, Redwood Creek, Russian River Estuary, Stone Lagoon, breach susceptibility index.

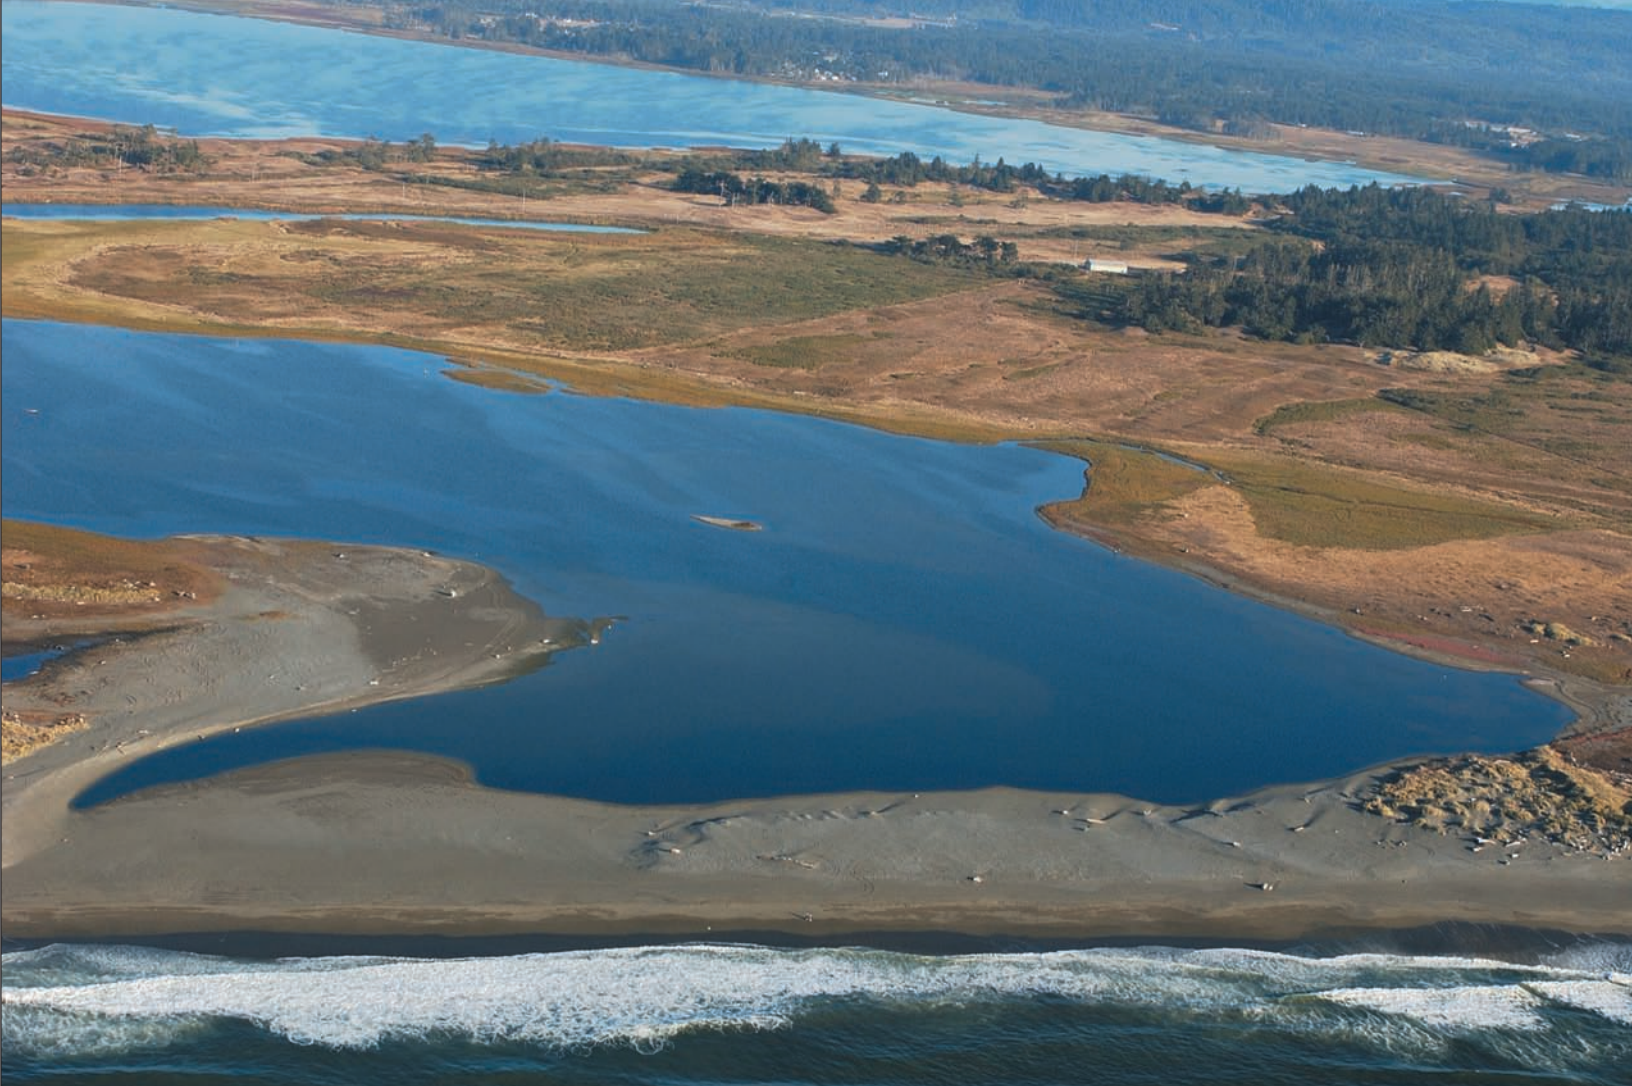
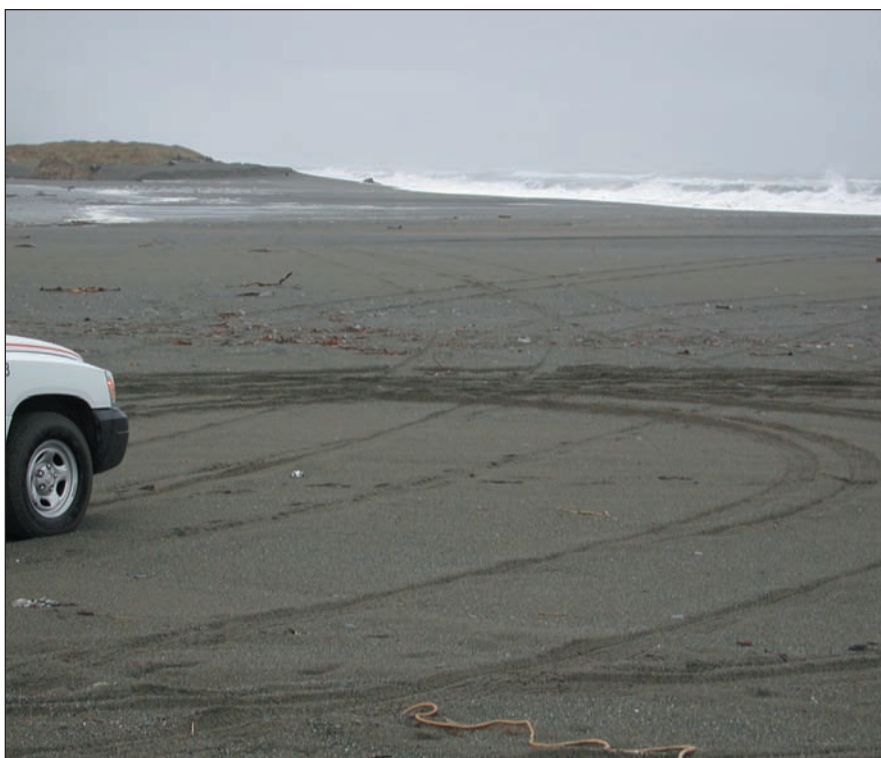
**Figure 4: (above) Lake Earl, 2002. Copyright © 2002-2007 Kenneth & Gabrielle Adelman, California Coastal Records Project, [www.Californiacoastline.org](http://www.Californiacoastline.org); (below) Lake Earl, December 2005, the day the barrier was breached (photograph courtesy Art Reeve, Del Norte County).**

The Lake Earl and Lake Tolowa lagoon complex, referred to collectively as Lake Earl, is located 11 km north of Crescent City in Del Norte County, in the Smith River Plain (Figures 3 and 4 [above]). Water quality and lagoon elevation rely on breaching of the barrier beach. Inflows of water into this lagoon

the breach susceptibility index for Lake Earl is 3-5 percent ( $\kappa$  values of half these), depending on the combination of parameters. Larger values indicate a greater incidence of breaching. A narrower beach and greater head difference produce a larger susceptibility index or possibility of a breach occurring. Figure 4 (below) is a picture of the barrier beach just before it was mechanically breached in December 2005. At that time the water level in the lagoon was 2.6 m MSL.

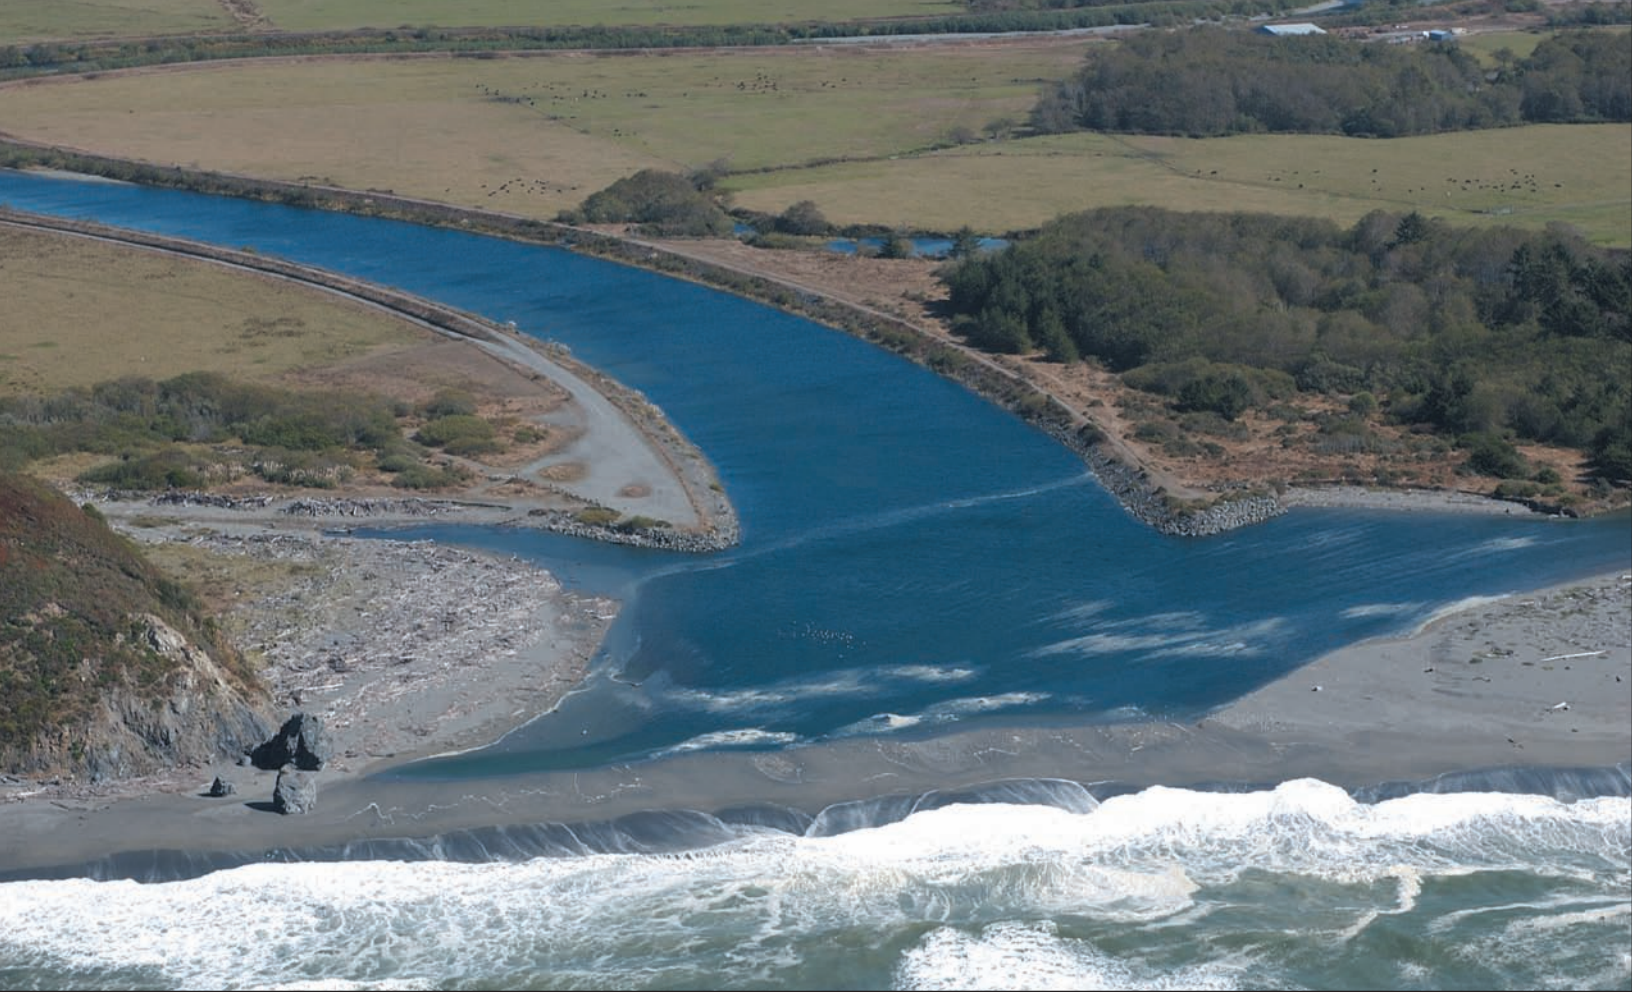
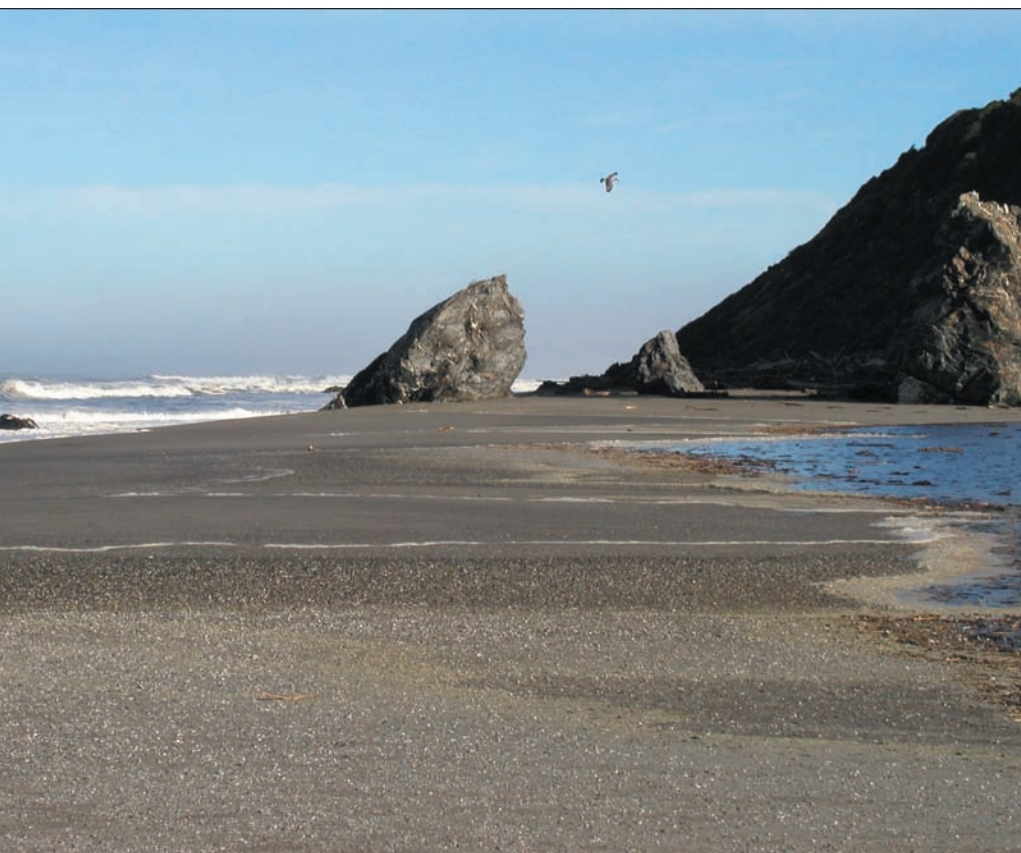
**Figure 5: (above) Redwood Creek, 2005. Copyright © 2002-2007 Kenneth & Gabrielle Adelman, California Coastal Records Project, [www.CaliforniaCoastline.org](http://www.CaliforniaCoastline.org); (below) Redwood Creek, October 2005, three weeks before breaching (photograph courtesy David Anderson, National Park Service).**

Redwood Creek Estuary is located in Orick, about 5 km north of Stone Lagoon (discussed below) in Humboldt County, and about 55 km north of Eureka (Figures 3 and 5). The mouth of Redwood Creek River is open to the Pacific Ocean most of the year, allowing sea water to be exchanged with the estuary. At the end of summer, when precipitation is infrequent, the river flow and tidal prism are not sufficient to maintain the inlet. As a result, a barrier beach forms at the mouth of the inlet, sealing the estuary from the ocean.

Figure 5 (below) is a photograph taken three weeks before the 2005 breach when the water level in the lagoon was 2.7 m. The picture shows the swash of the waves during high surf over the lower portion of the barrier beach and sand on the surface of the barrier being wetted by groundwater probably seeping from the lagoon to the ocean. Barrier beaches might be lowered by seepage, initiating overflow from the lagoon to the ocean.

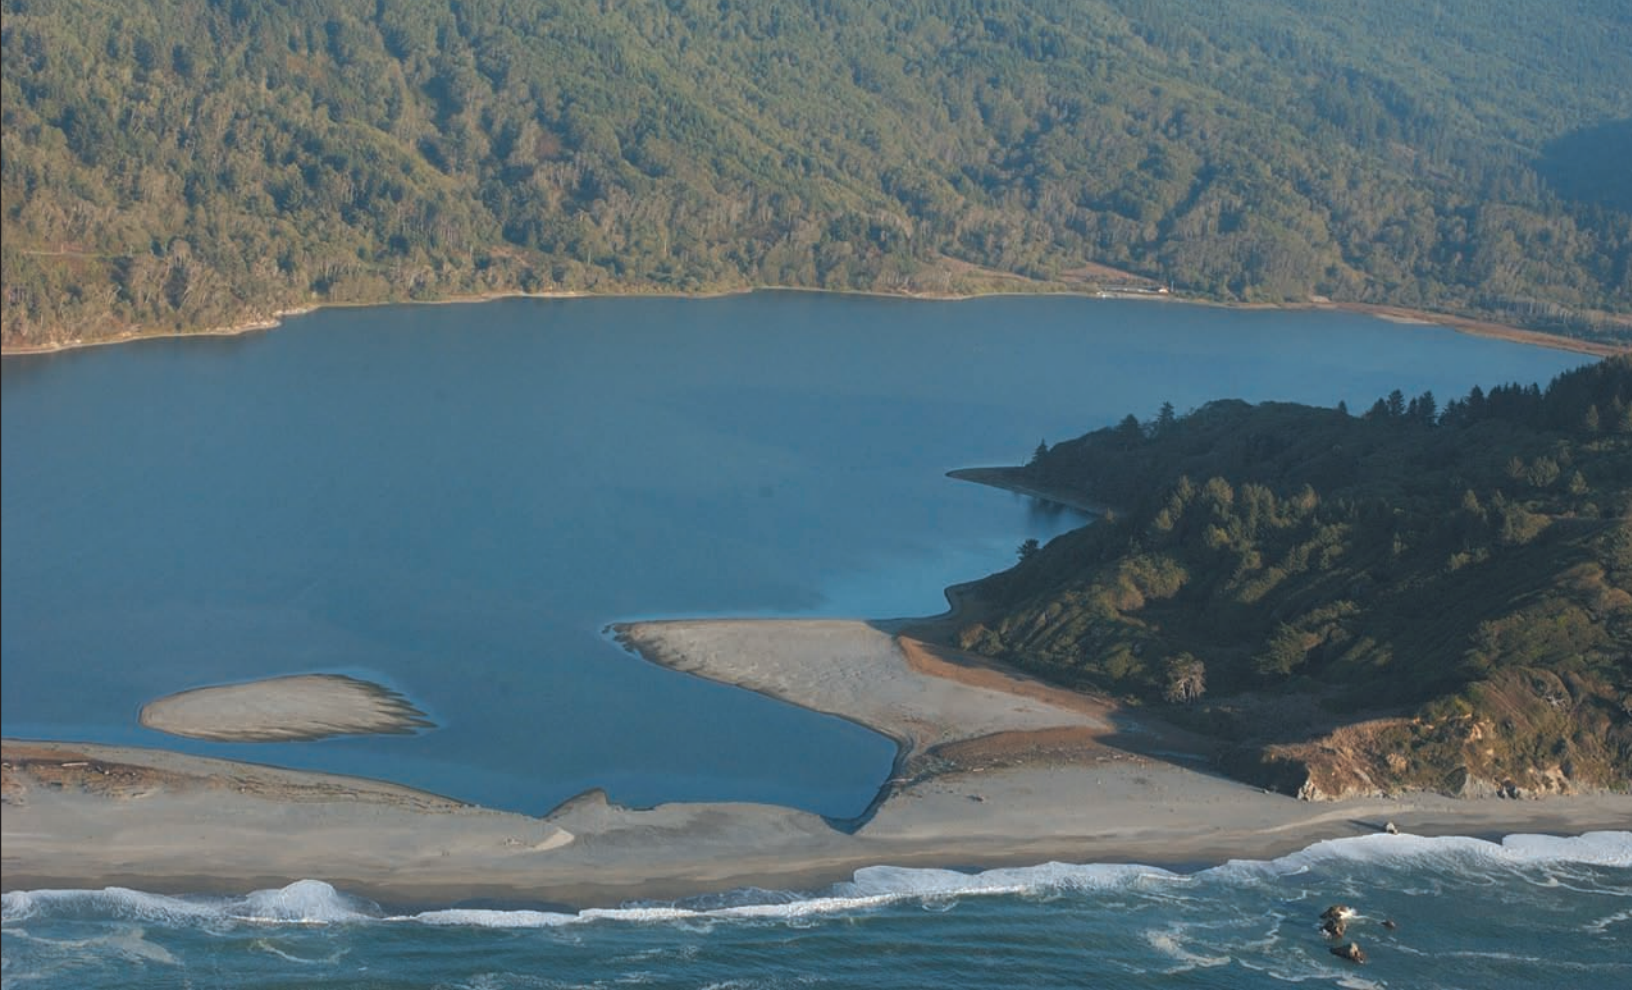
Figure 6 (above): Stone Lagoon, 2002. Copyright © 2002-2007 Kenneth & Gabrielle Adelman, California Coastal Records Project, [www.Californiacoastline.org](http://www.Californiacoastline.org).

Stone Lagoon is one of four lagoons of Humboldt Lagoons State Park and is located 50 km north of Eureka (Figures 3 and 6). This stretch of northern coastal California is characterized by steep, rocky headlands punctuated by pocket beaches and lagoons backed by mountain slopes and meadows. A straight, predominantly uniform-width barrier beach stretches between headlands separating Stone Lagoon from the Pacific Ocean. Stone Lagoon, fed by small streams, usually breaches from October to April, during or near the end of the rainy season (Joseph 1958). Although natural breaching of Stone Lagoon is initiated by a large water-head difference between the lagoon waters and the ocean, once the barrier is breached, the water level in the lagoon reaches near equality with sea level within a day or so.

These breaches form at the southern end of the barrier beach, just north of a group of rocks offshore that might act as a porous groin in limiting longshore sediment transport in their vicinity. Stone Lagoon continues to breach at the same general location, the southern end of the barrier beach. Prior to these natural breaches, the water-head difference between the lagoon elevation and MSL in the Pacific Ocean is typically 3-4 m with a barrier width of 30-50 m on average,

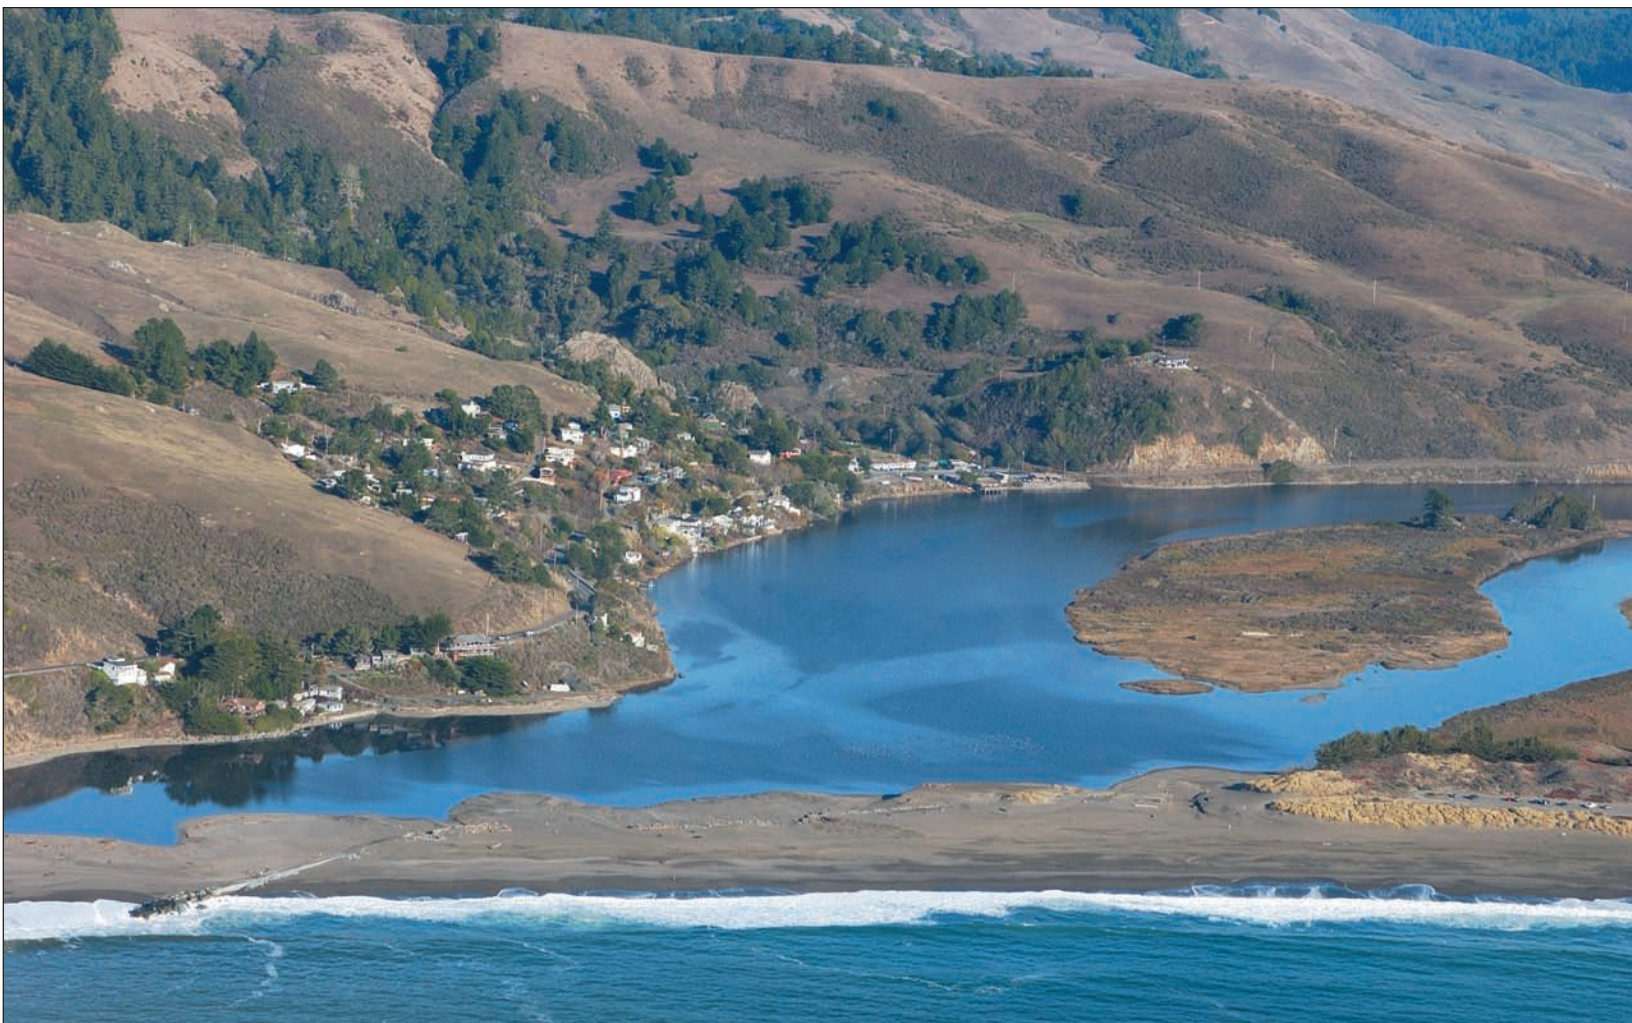
Figure 7 (below): Russian River Estuary, 2002. Copyright © 2002-2007 Kenneth & Gabrielle Adelman, California Coastal Records Project, [www.Californiacoastline.org](http://www.Californiacoastline.org).

The Russian River Estuary (Figures 3 and 7) is located approximately 95 km northwest of San Francisco in Sonoma County. Near the mouth of the Russian River, the coast is punctuated by small pocket beaches separating steep, rocky cliffs. For portions of the year, the mouth of the river is functionally closed by a barrier beach because the tidal prism coupled with the stream flow are insufficient to keep the inlet open year round (Rice 1974). The Russian River Estuary and watershed are designated as critical habitat for threatened stocks of salmon and steelhead. The estuary must be maintained for fish production and passage as well as for flood control, channel maintenance, water storage, and hydroelectric power generation. Development of a management plan that satisfies all of these needs is difficult. To date, there is no regular pattern of barrier beach closing and breaching; however, under recent flow conditions, the barrier beach must be manually breached several times in the fall. The Russian River Estuary typically remains open naturally in the winter and spring, and oftentimes remains open until the early summer (Entrix Inc. 2001).

The primary action in the management of this estuary is manual breaching of the barrier beach that forms across the mouth of the estuary. The mouth of the Russian River is managed as an estuary (defined as the beach-open condition) rather than a lagoon (beach-closed condition), thus limiting the bar-closed episodes to 7-10 days (Entrix Inc. 2001). In addition, the water level in the estuary is kept below 2 m. The short duration of barrier closure promotes water quality yet decreases flooding hazards that develop in the beach-closed condition (Entrix Inc. 2001; Merritt Smith Consulting 1998, 1999, 2000). By analyzing aerial photography found in Goodwin and Cuffe (1994) to estimate barrier beach width during breaching and lagoon elevations at the time of manual breaches, a susceptibility index for this estuary was found to be between 3% and 5%.

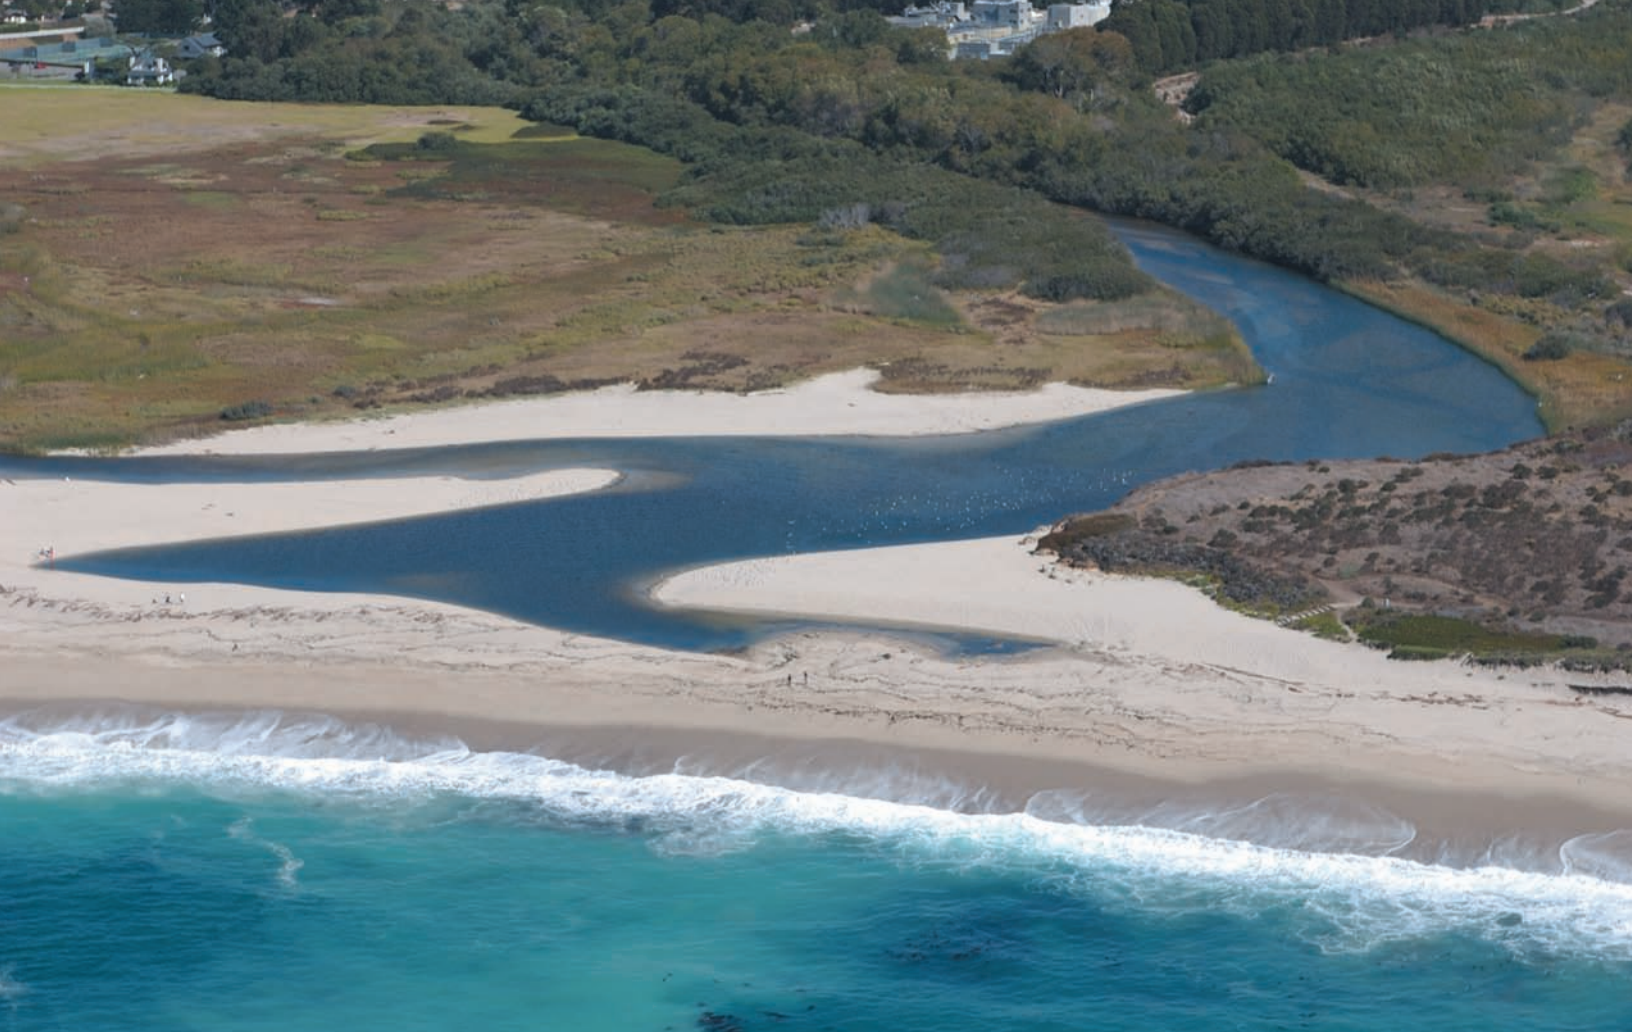
**Figure 8: Carmel River Lagoon, 2004. Copyright © 2002-2007 Kenneth & Gabrielle Adelman, California Coastal Records Project, [www.Californiacoastline.org](http://www.Californiacoastline.org).**

Carmel River Lagoon (Figure 3 and Figure 8) is located about 200 km south of San Francisco. It and the adjacent approximately 2-km-long barrier beach

In the present study, beach width and lagoon elevation at the times of breaching were estimated from aerial photographs to determine the breach susceptibility index for the Carmel River Lagoon. An average water-head difference between the lagoon and MSL was found to be 3 m with an associated beach width of between 30 m and 75 m at the time of breaching. The beach width varied greatly depending on where the lagoon breached and the resulting meanders in the outlet channel. The breach susceptibility index for Carmel River Lagoon was found to be between 5% and 10%. Once again, the susceptibility index is greater with a larger water-head difference between the ocean and the lagoon and a narrower beach width.
